## CAFO WPDES Compliance Report (6-12-14)

Inspection date: April 24, 2014

Operation Name: Thompson's Gold Dust Dairy

WPDES Permit No. WI-0058386-04-0

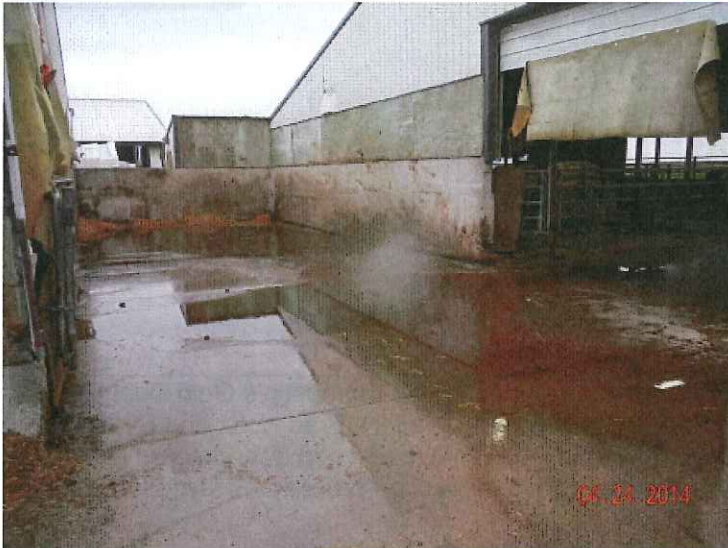
Photo 2 (above): View of area between buildings 3 & 4. Jim stated that no manure is stored in this location. Some faintly brown discolored rain water was present in this location.

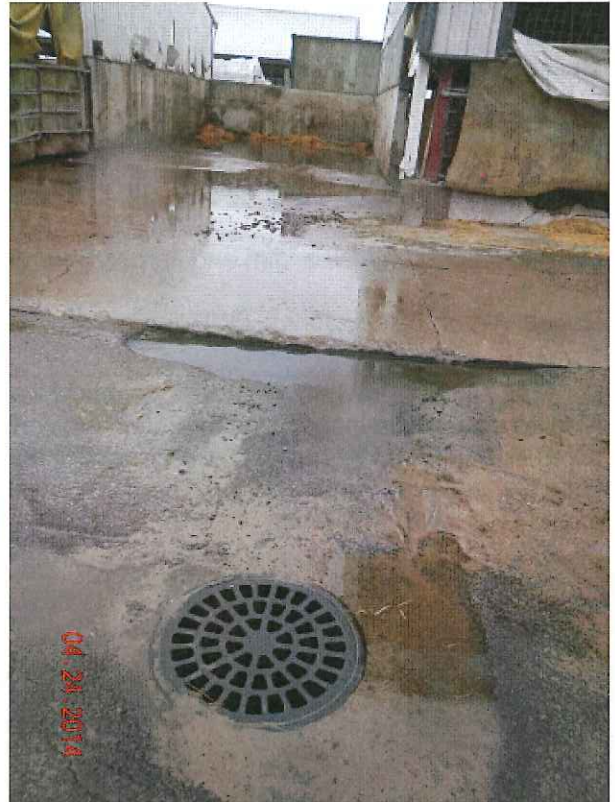
Most animals at Gold Dust Dairy are all confined under roof in buildings. The calf hutch area between buildings labeled 2 and 3; the hutches on east end of southern calf barn; and the storm water manhole drain shown on overview map (photo 1) may be contributing to the bacteria detected in water samples.

Photo 3 (right): View of storm water manhole that accepts rain water.

- Remove any unknown exposed tile outlets.
- Assessment of options for manhole opening that accepts storm water drainage between barns. It is likely that during heavy rain events, some manure mixes with storm water and discharges with storm water.

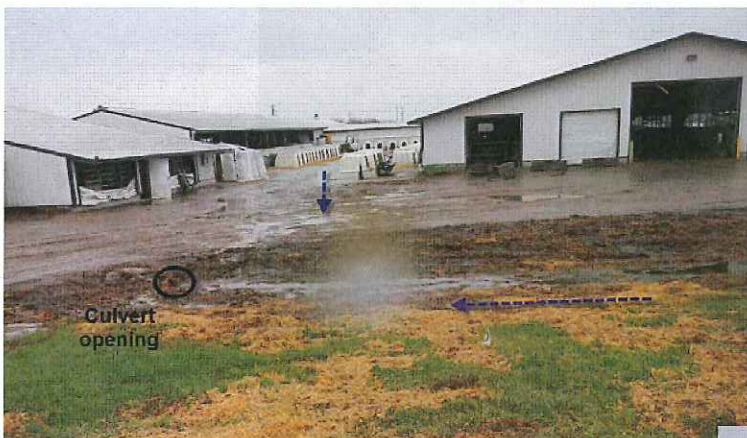
Photo 4: Looking west at small calf hutch area that drains to storm water ditch. Hutches did not have calves in them at time of inspection; hutches were bedded with clean straw (no manure present).

- Relocation or abandonment of any outdoor calf hutch areas. Areas should not be near any storm water flow paths to prevent migration of manure into storm water ditches.

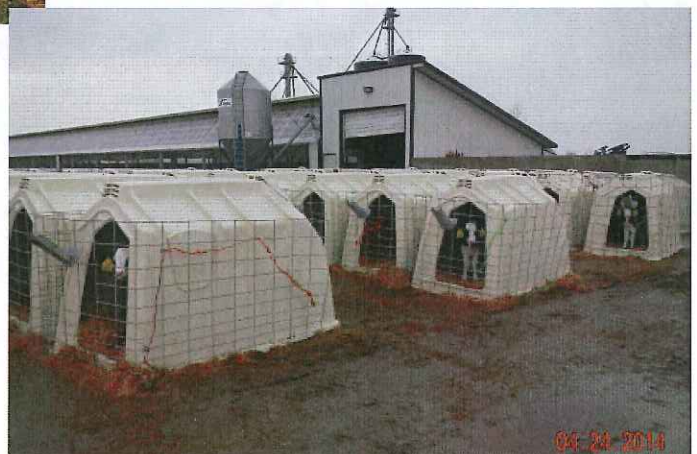
Photo 5: View of small calf hutch area on east end of the southern calf barn.

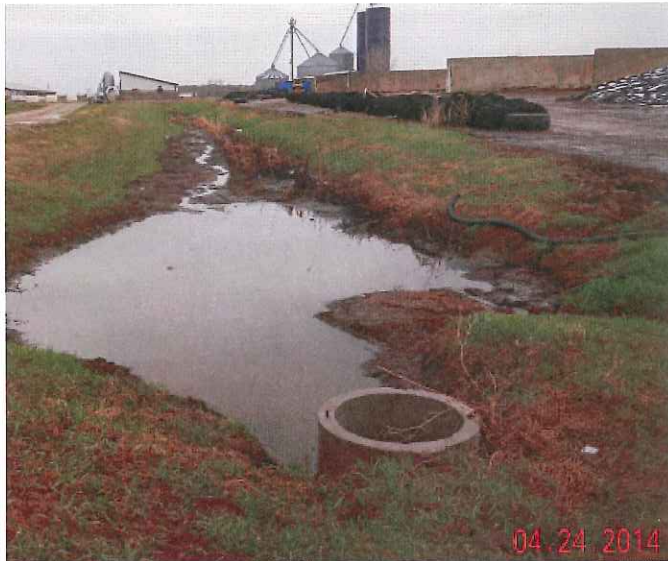
All runoff from feed bunkers is directed into basin/ditch that flows into a small collection tank. A pump has been added to the collection area to pump directly into WSF 1. If the pump cannot keep up during a rain event, runoff flows into adjacent clay collection basin, at some point the diluted storm water runoff reaches the pipe that outlets into the vegetated treatment area (VTA). The VTA has had grading issues since it was constructed, runoff does not properly disperse evenly across VTA resulting in channelized flow discharging to culvert connected to drainage ditch.

Photo 6: View looking west at leachate and runoff collection ditch/basin for feed storage bunkers.

- Hire an engineer to assist with designing upgrades to the feed storage area runoff system. Modifications are required to stop the discharges from this area. Modifications that were completed without review (pump installation and transfer line) and proposed modification need plan review and approval from the Department.

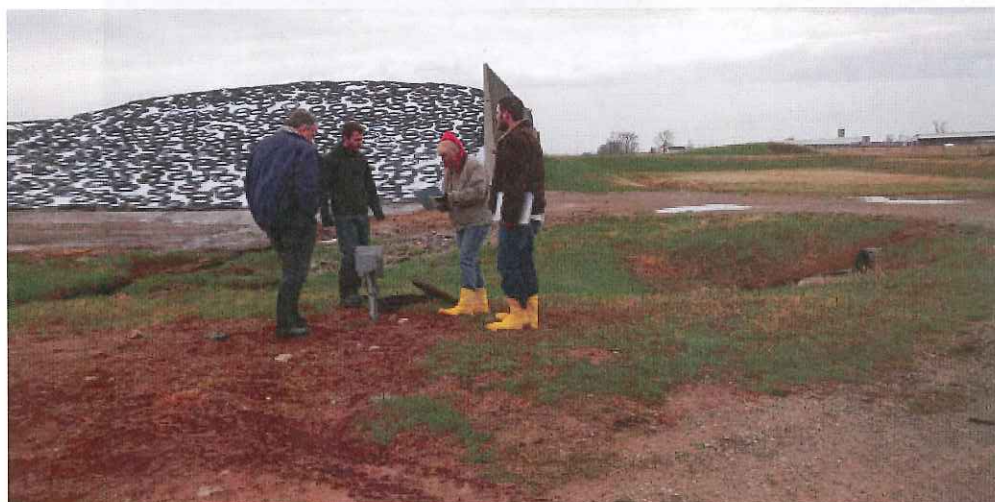
Photo 7 (left): Looking north at runoff pump station area.

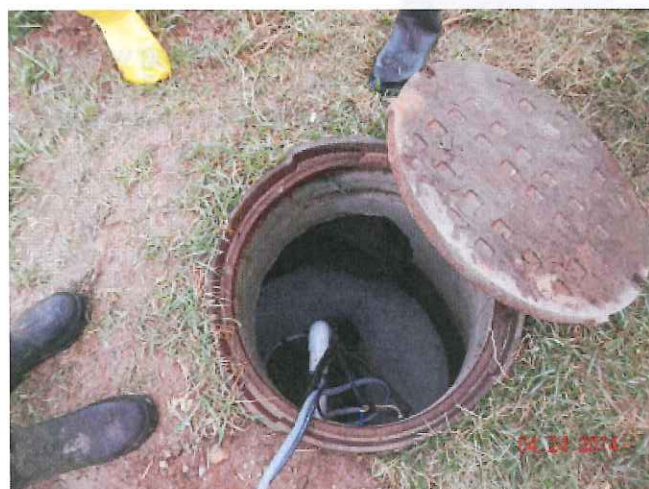
Photo 8 (bottom left): Close view of collection tank and pump. Runoff is pumped into the adjacent waste storage facility.

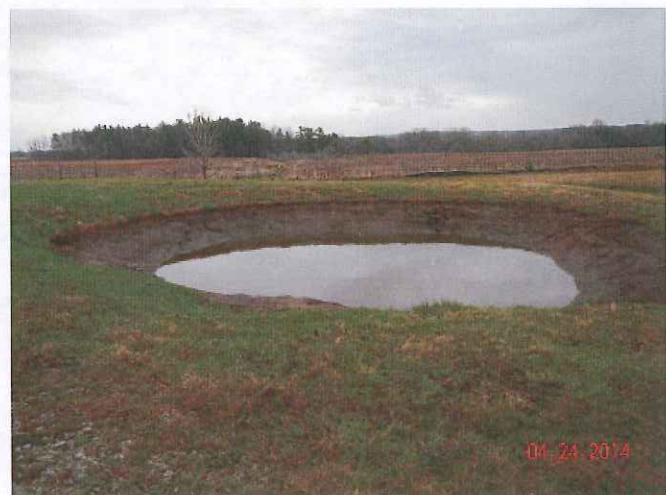
Photo 9 (bottom right): Looking east at clay overflow runoff collection basin.

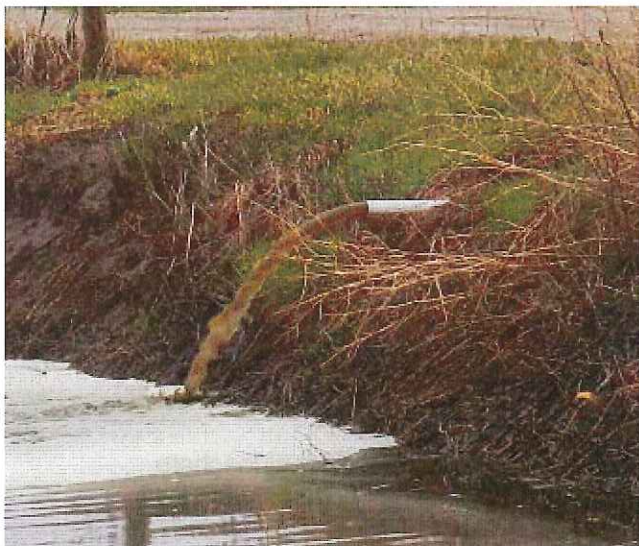
Photo 10 (left): View of pipe discharging feed storage runoff water into WSF 1.

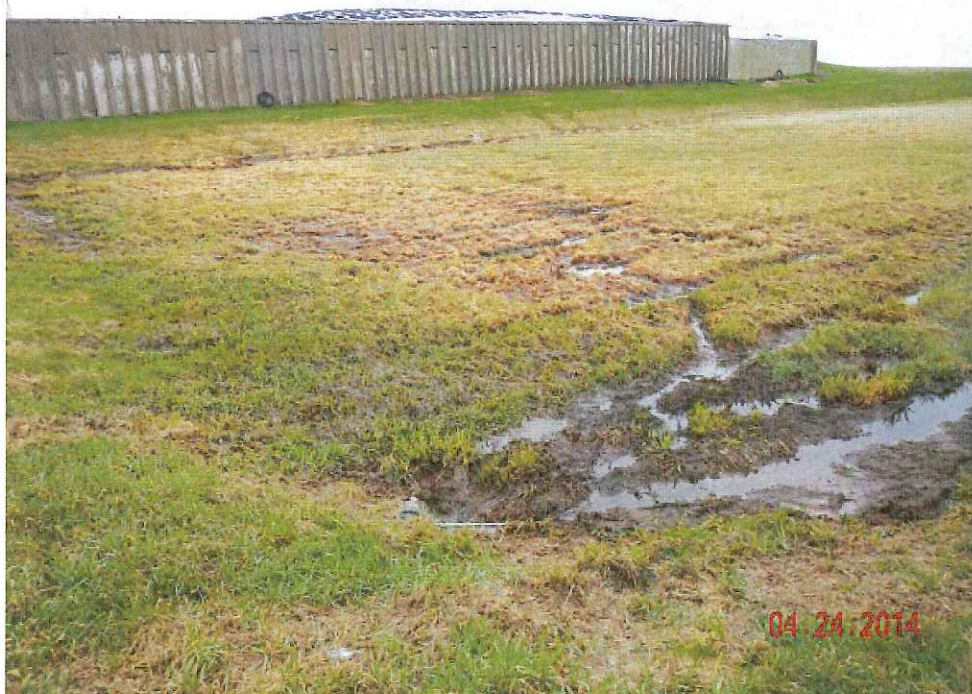
Photo 12: Looking west at VTA with channelized runoff flow into culvert inlet (in foreground).

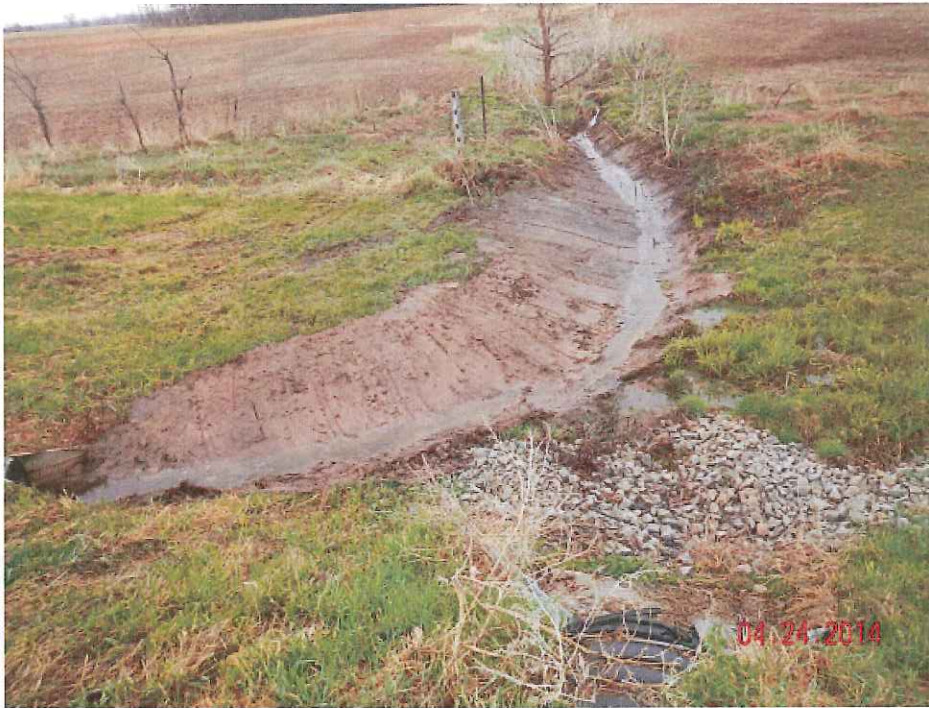
Photo 13: View of culvert outlet from VTA that discharges into drainage ditch leading to the East River. Drainage path had been recently dredged.

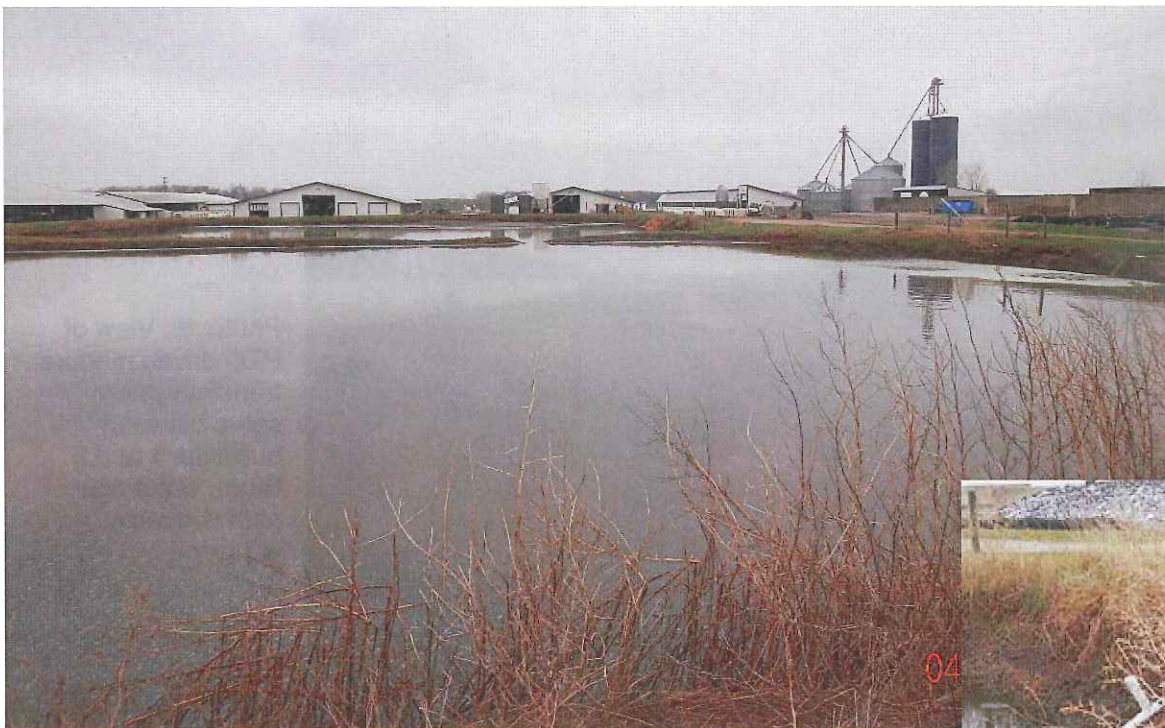
Gold Dust Dairy has two large earthen waste storage facilities (WSF). WSF 1 is a two-celled earthen storage and accepts waste from the feed storage area, parlor and northern barns. WSF 2 is an earthen storage accepting waste from the southern freestall barns. Storages were operating below the maximum operating level at time of inspection. MOL markers were installed in both storages. Agitation pads should be added to storages.

Photo 14 (above): Looking west at WSF 1, cell divider for sand settling was visible in center of storage.

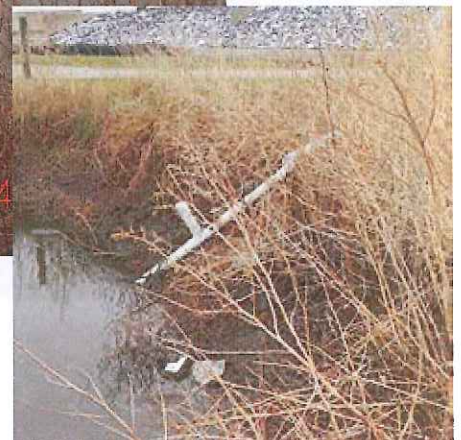
Photo 15 (right): View of MOL marker in WSF 1.

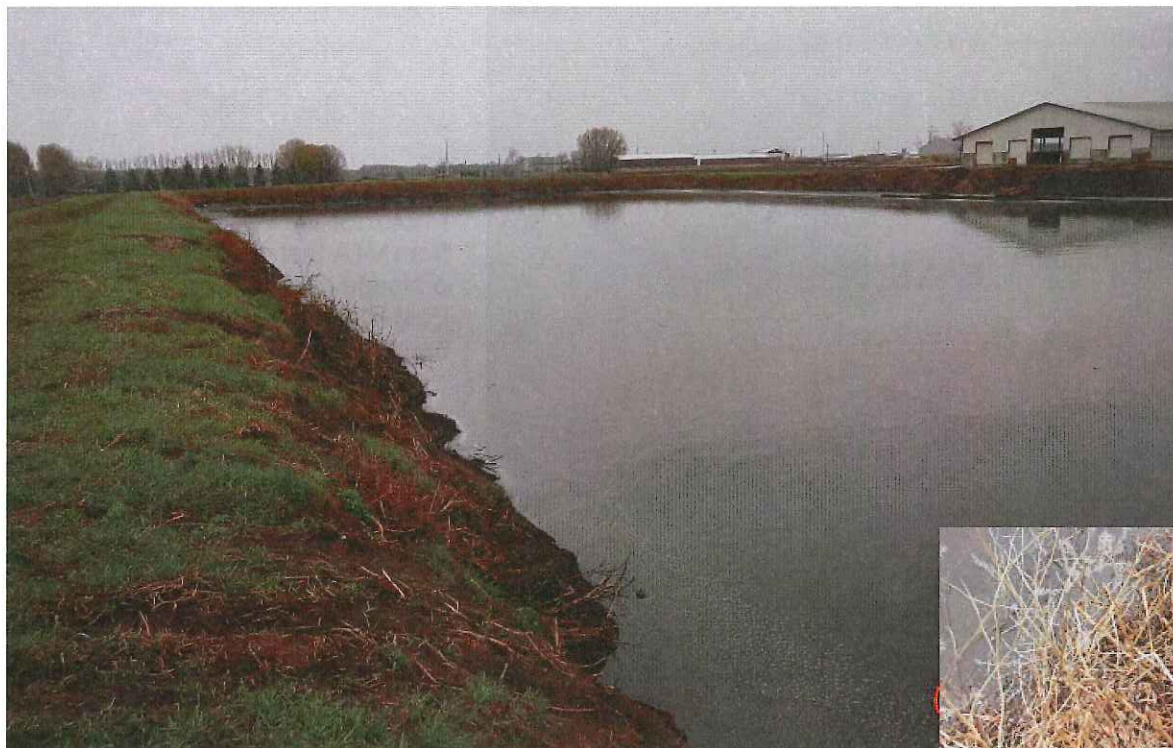
Photo 16 (above): Looking south at WSF 2.

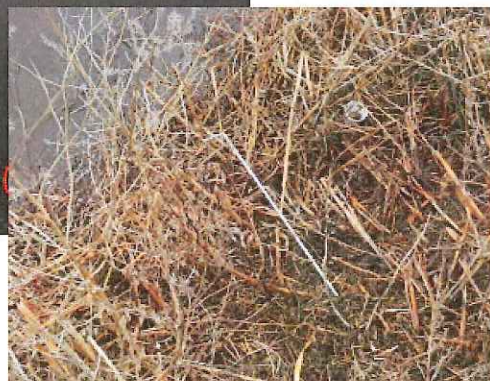
Photo 17 (right): View of temporary MOL marker in the southwest corner of WSF 2; previous PVC marker had broken.

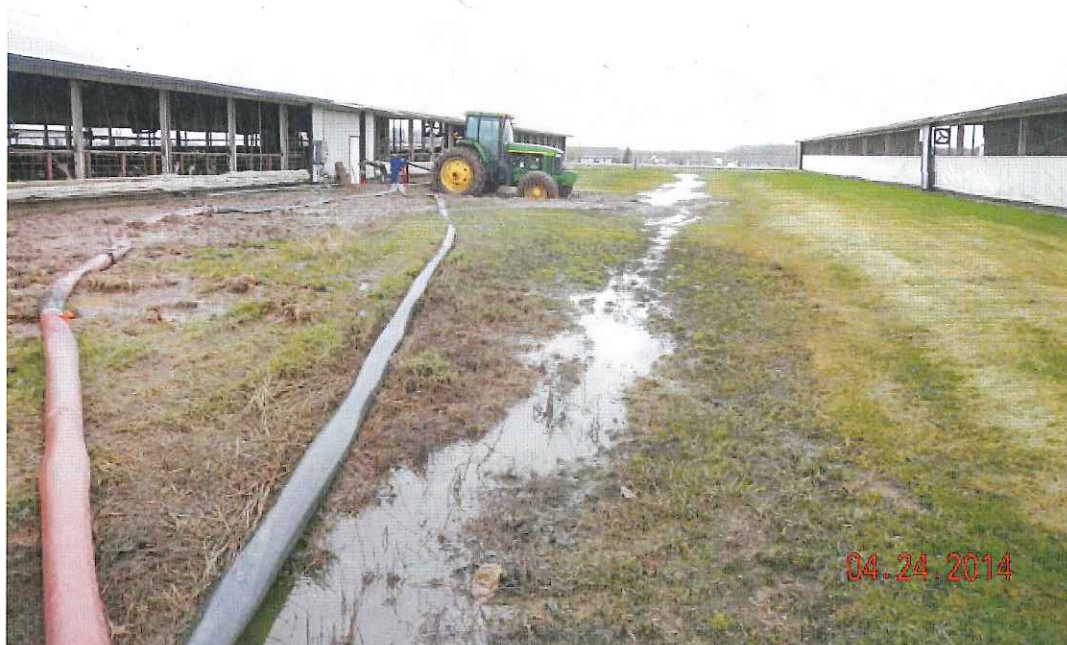
Photo 18: View of PTO driven manure transfer system setup between buildings 1 and 2. Storm water flow path is directly adjacent.

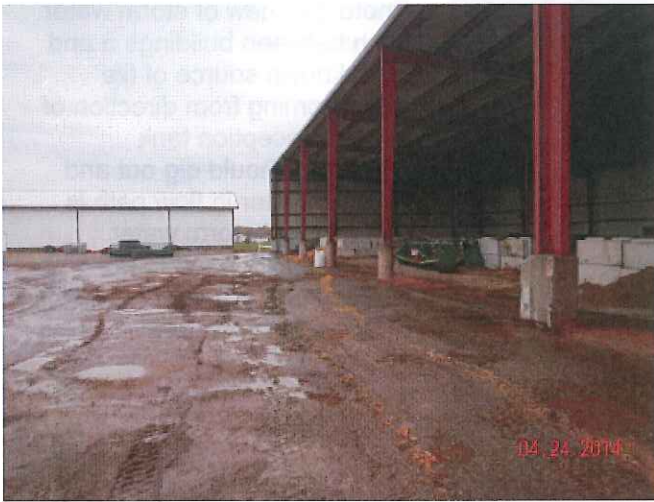
Photo 19 (left): Looking west in front of former dry storage building which now houses calves. Storm water flow path is west then north.

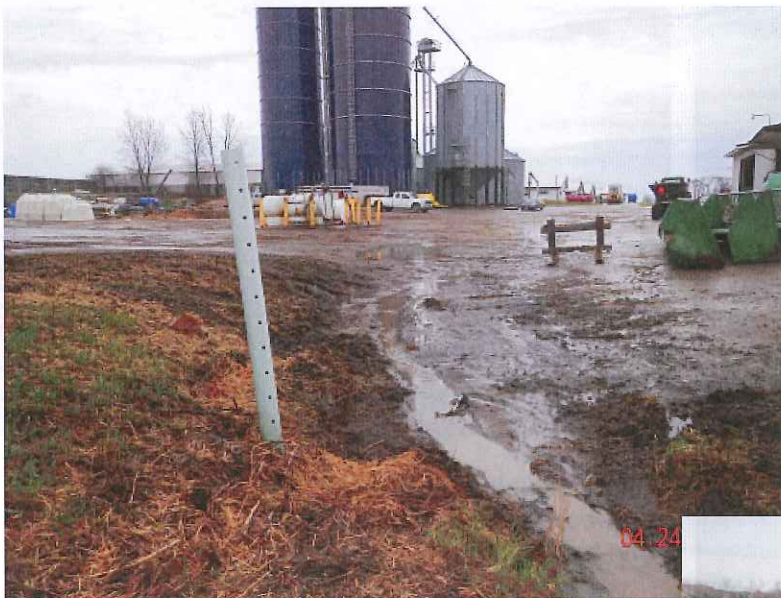
Photo 21: View looking south at storm water flow from driveway area. Tile inlet is no longer functional. Thompson indicated that they have been unable to locate an outlet for the tile system.

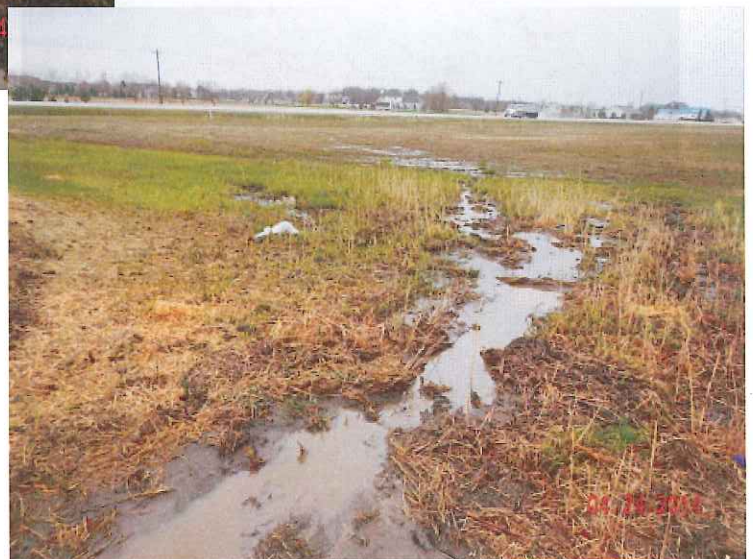
Photo 22: Looking north at flow path into field that eventually discharges to road ditch. Water was turbid and cloudy but did not appear to contain waste stream.

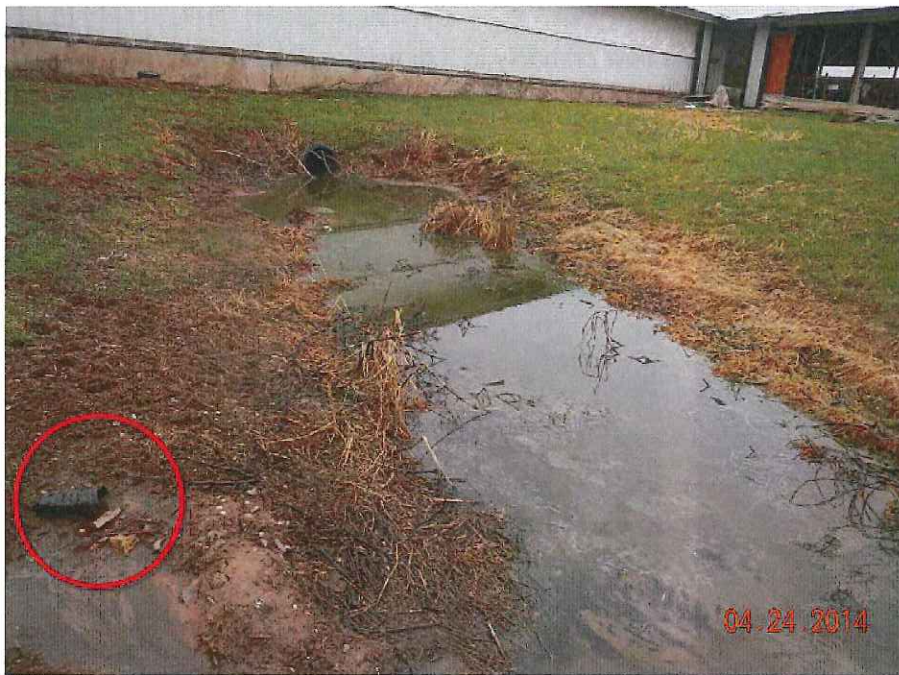
Photo 23: View of storm water ditch between buildings 5 and 6. Unknown source of tile outlet coming from direction of manure reception tank building—should dig out and cap off. Water in flow path is murky, most storm water ditches onsite need to be cleaned out, graded properly and seeded down and stabilized.

- During dry conditions, clean out and regrade all storm water ditches. This will remove any residual contaminants. Ditches should be shallow swales that are completely vegetated and regularly mowed.

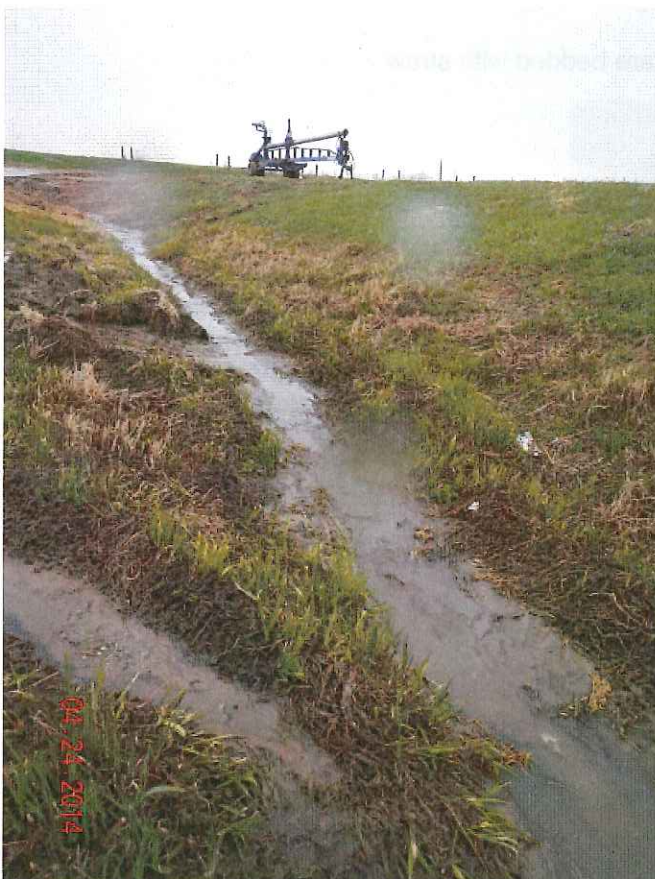
Photo 24 (left): Looking north at storm water ditch between waste storage and barns. Water was murky and turbid.

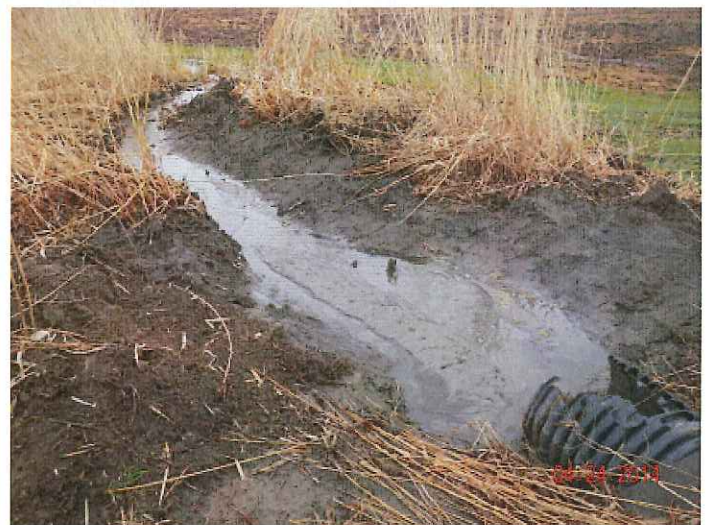
Photo 25 (above): View of storm water outfall on southeast corner of Gold Dust Dairy that discharges to the East River.

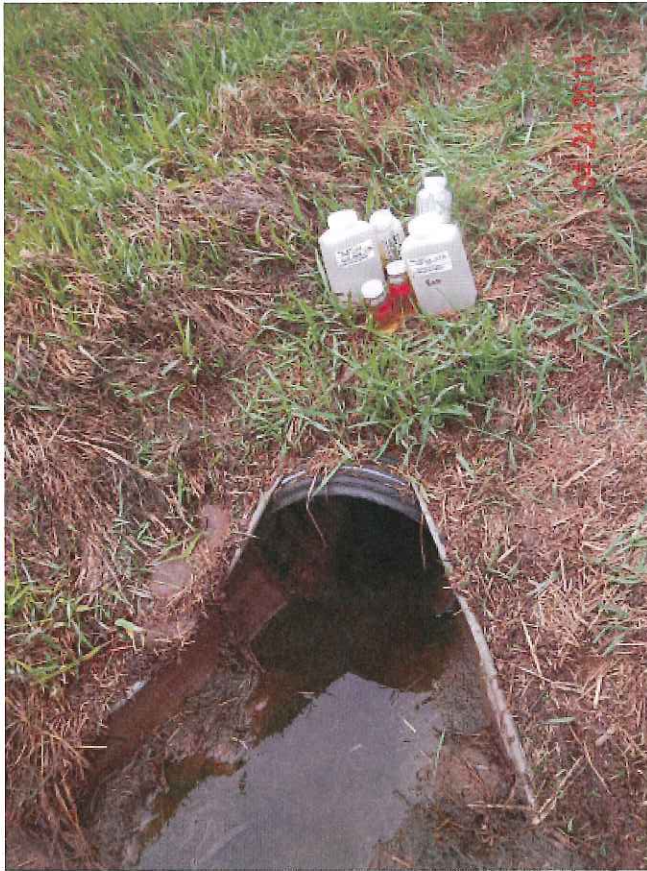
Total Coliform	500/cfu 100 mL
Enterococci	1310/100 mL
E Coli	500/100 mL
BOD 5 Day	No Detect
Nitrogen NH3-N Diss	24.8 MG/L
Nitrogen NO3+NO2 Diss	0.0519 MG/L
Nitrogen Kjeldahl Total	49.2 MG/L
Phosphorus Total	10.1 MG/L

Photo 26 (above): View of sample GD-01 of vegetated treatment area discharge culvert.

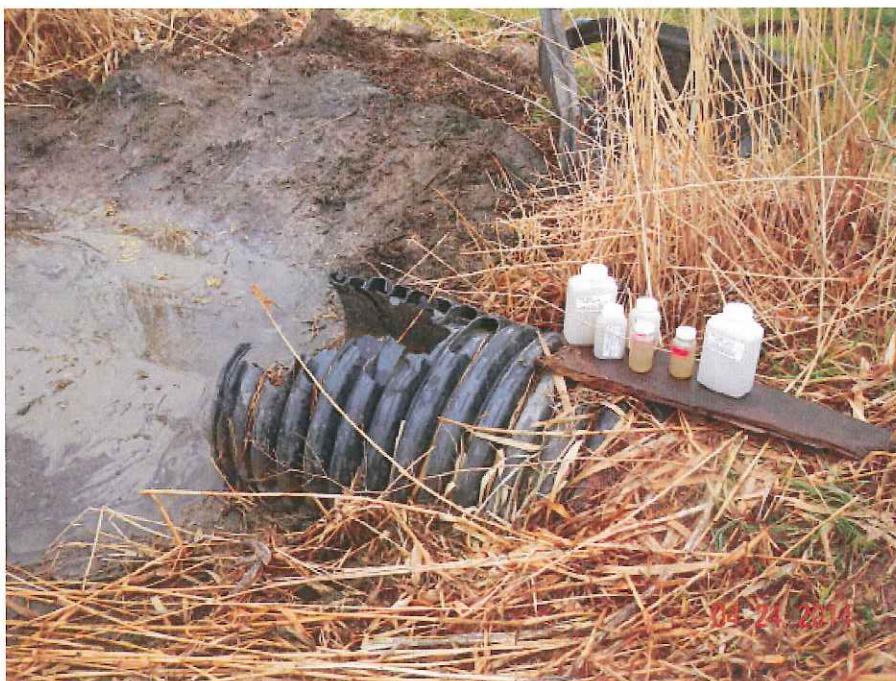
Total Coliform	9000/cfu 100 mL
Enterococci	2330/100 mL
E Coli	9090/100 mL
BOD 5 Day	No Detect
Nitrogen NH3-N Diss	8.50 MG/L
Nitrogen NO3+NO2 Diss	0.721 MG/L
Nitrogen Kjeldahl Total	21.4 MG/L
Phosphorus Total	3.79 MG/L

Photo 27 (below): View of sample GD-02 of storm water ditch discharge culvert.
